UPPER MILLPOND DAM  
CT 00390

INDIAN RIVER BASIN  
CLINTON, CONNECTICUT

PHASE I INSPECTION REPORT  
NATIONAL DAM INSPECTION REPORT

Re: Upper Millpond Dam  
Clinton, Connecticut  
Contract # DACW -33-81-C0017

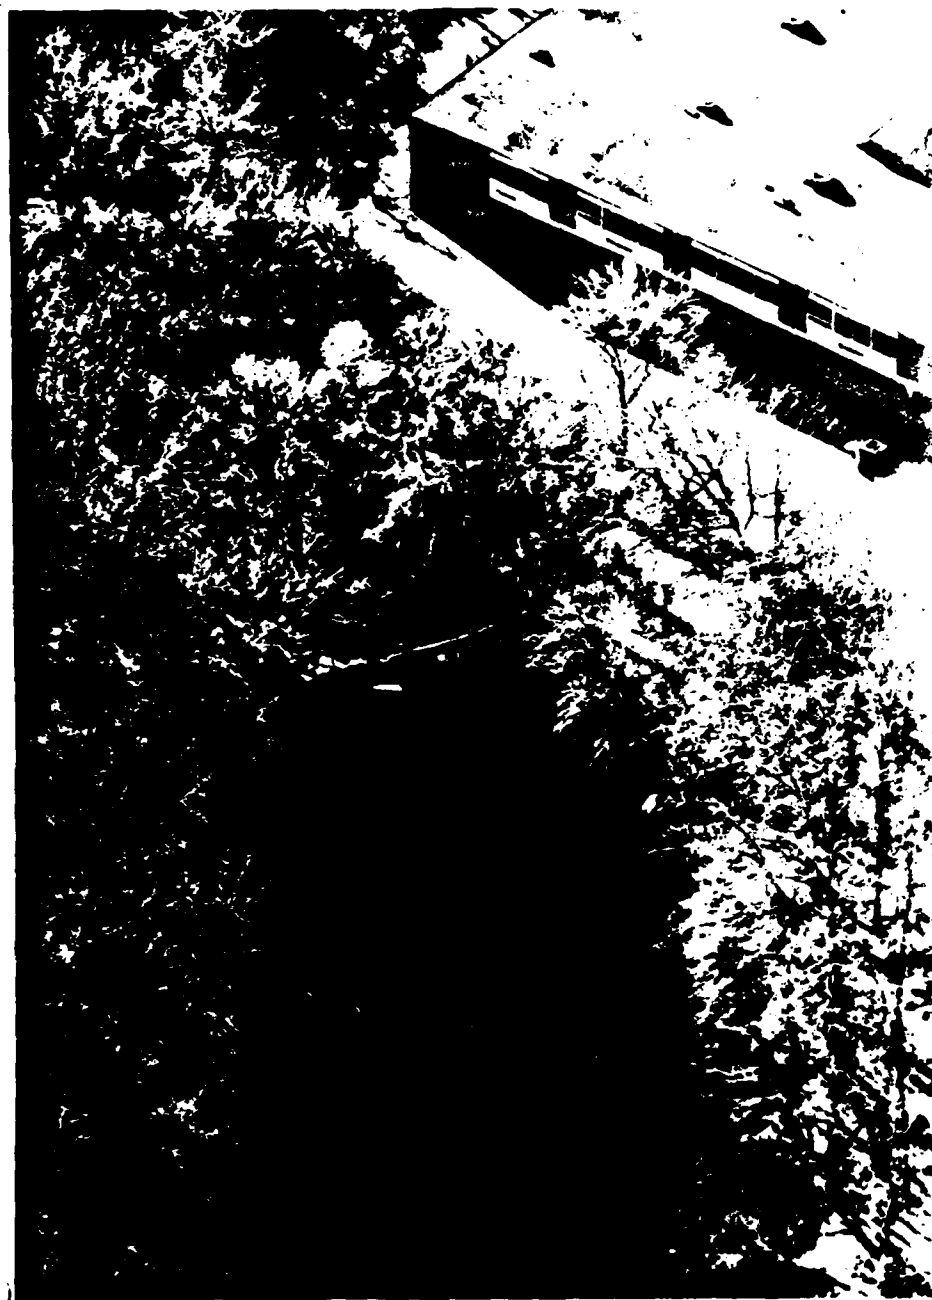
OVERVIEW PHOTO

The dam is in fair condition with some cracking and spalling of the concrete cap, no functioning outlet works, several large overhanging trees just upstream of the dam, measurable seepage around the left abutment and some misalignment of the stone masonry dam itself.

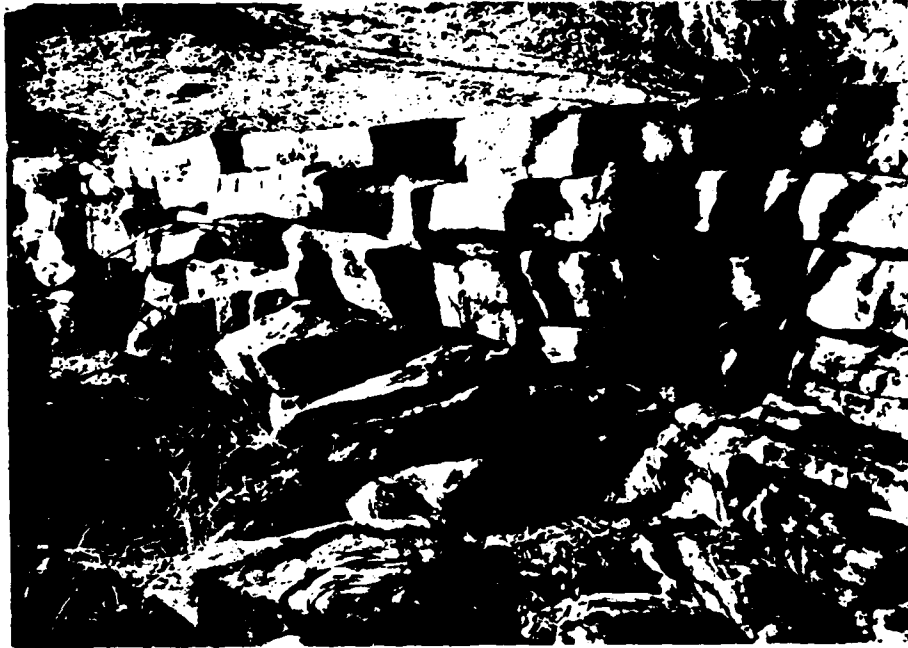
4. Downstream face of dam taken from about Sta 0+50 looking toward right abutment.

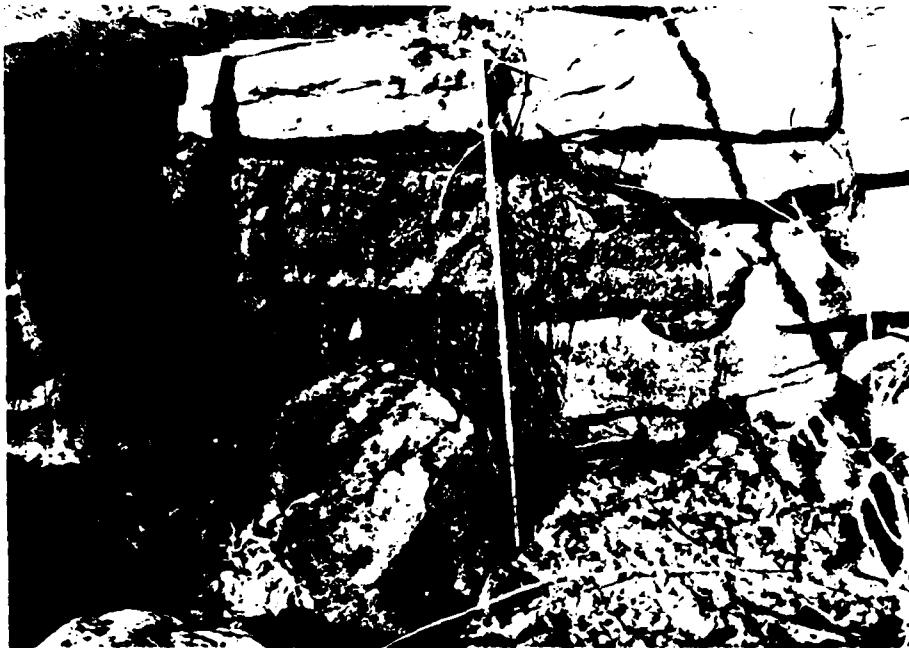
6. Water seeping through downstream face of dam at about Sta 0+15. Ruler extended 5 feet.

AREA EVALUATED	CONDITIONS
<u>DAM EMBANKMENT</u>	No embankment - stone masonry dam.
Crest Elevation	91.8
Current Pool Elevation	91.2
Maximum Impoundment to Date	
Surface Cracks	Concrete cap at about Sta 0+52 has spalled in some areas.
Pavement Condition	No pavement.
Movement or Settlement of Crest	At Sta 0+15, Sta 0+25 to Sta 0+35 and at Sta 0+78, some blocks have moved downstream and downward. At Sta 0+15 a stone has apparently fallen out of an old sluiceway.
Lateral Movement	Fair.
Vertical Alignment	Poor.
Horizontal Alignment	Fair.
Condition at Abutment and at Concrete Structures	Fair.
Indications of Movement of Structural Items on Slopes	None observed.
Trespassing on Slopes	N/A
Sloughing or Erosion of Slopes or Abutments	None observed.
Rock Slope Protection - Riprap Failures	No riprap observed.
Unusual Movement or Cracking at or near Toes	None observed.
Unusual Embankment or Downstream Seepage	Water flowing through downstream face of dam at Sta 0+15, Sta 0+30 and Sta 0+78.

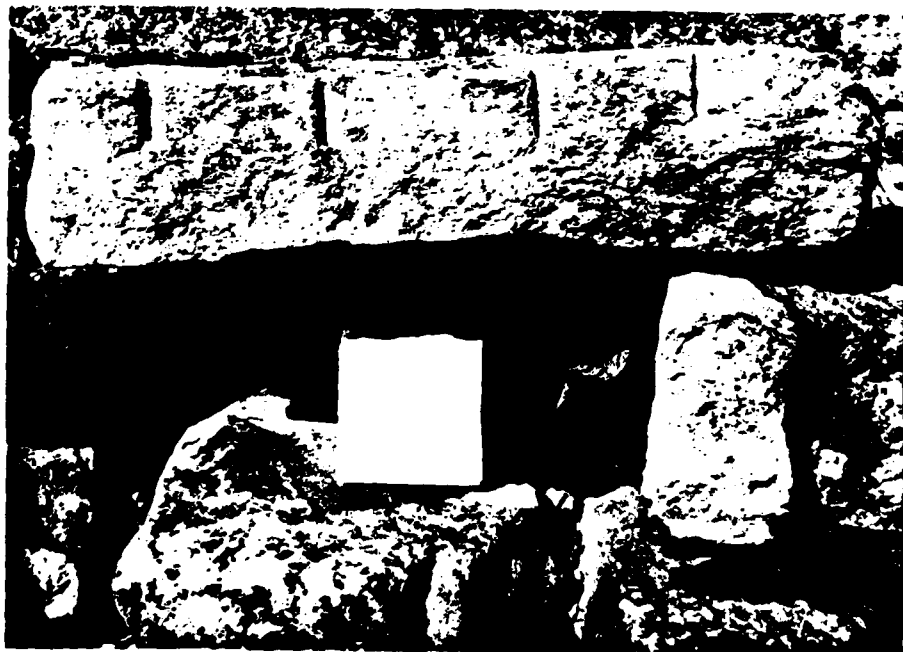
7. Large opening in downstream face of dam at about Sta 0+25. Opening is about 3-ft-wide and 1.5-ft-high and extends about 3 feet into the dam.
